**DRAFT REPORT
2017 MONITORING REPORT**

GRAND COUNTY, COLORADO

February 26, 2018
Revised April 13, 2018

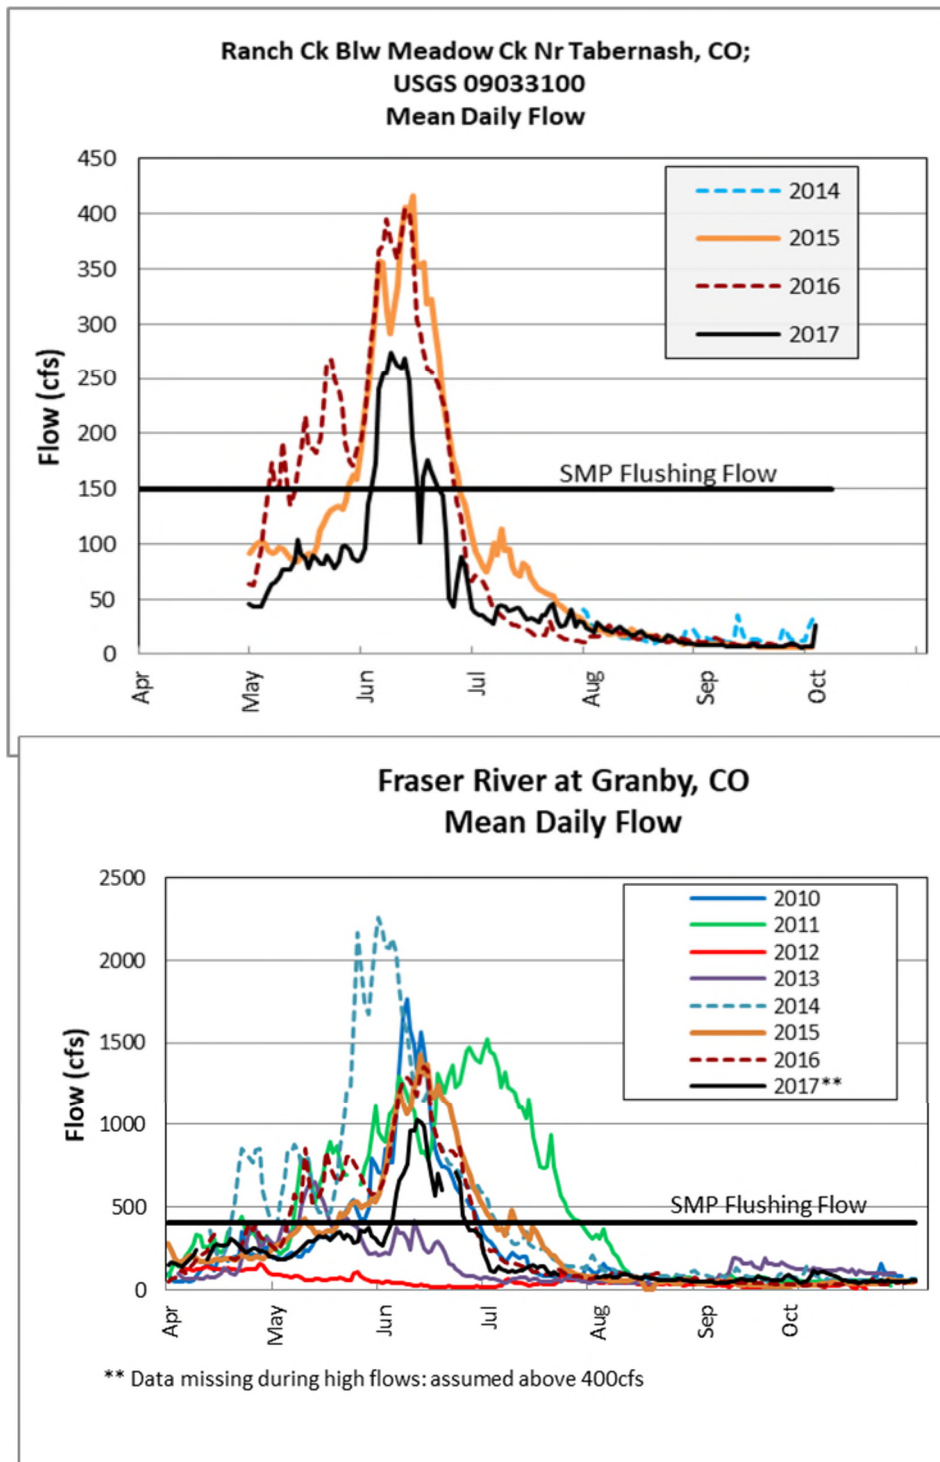
Figure 2 April through October hydrographs for Fraser River (2010-2017) and Ranch Creek below Meadow Creek (2014-2017) in Grand County, CO. Hydrographs depict time period of interest or as limited by available data.

2017 spring runoff in the Fraser River watershed was lower than those observed in 2014 to 2016, but 6.5 and 1.6 times higher than those experienced in the dry years of 2012 and 2013, respectively (**Figure 2 and Table 4**). The Fraser River at Granby peaked near mid-June at 1,028 cubic feet per second (cfs), while the peak observed on its tributary Ranch Creek was 272 cfs. The peak on the Fraser has a return interval slightly lower than 3-years based on the 1986 to 2016 period of record (Appendix A). Flows remained high throughout June declining to base levels in July. The recommended flushing flows (Table 4) on the Fraser River and Ranch Creek were exceeded in both magnitude and duration.

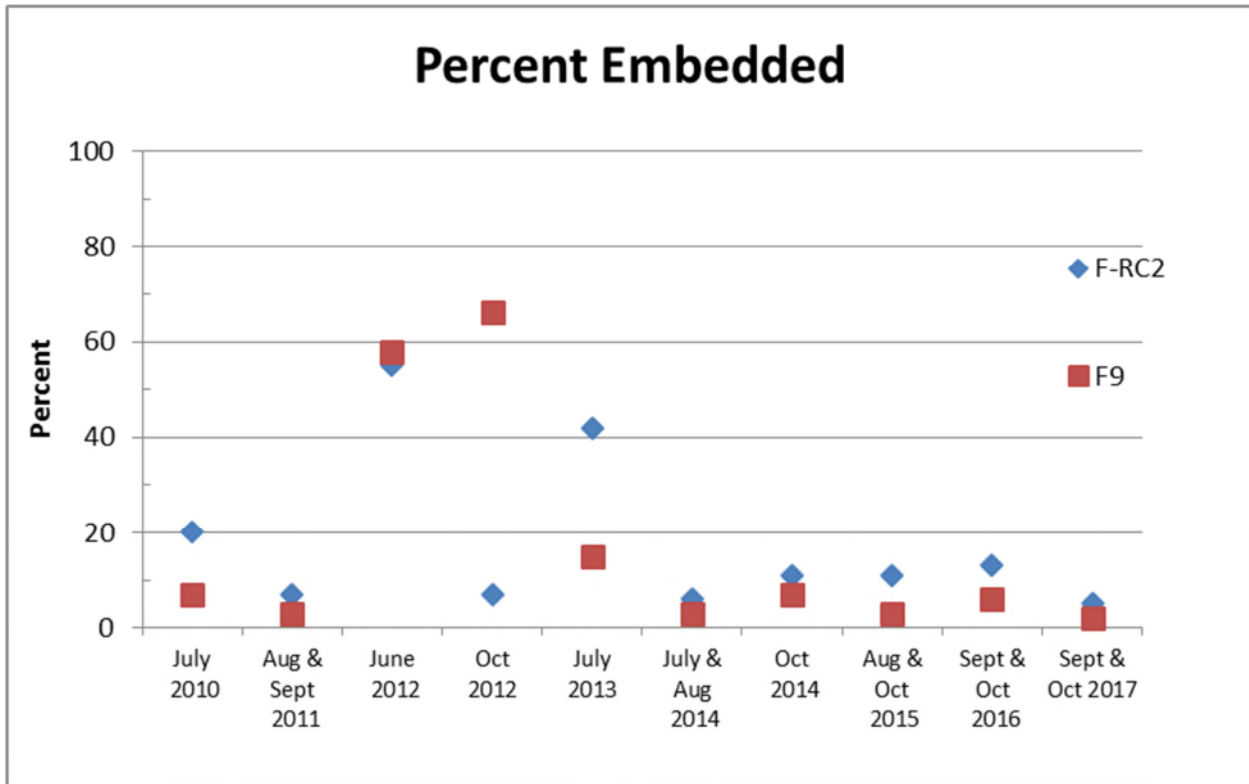
Figure 3 Percent of spawning bar embedded at Fraser River and Ranch Creek sites, 2010-2017.

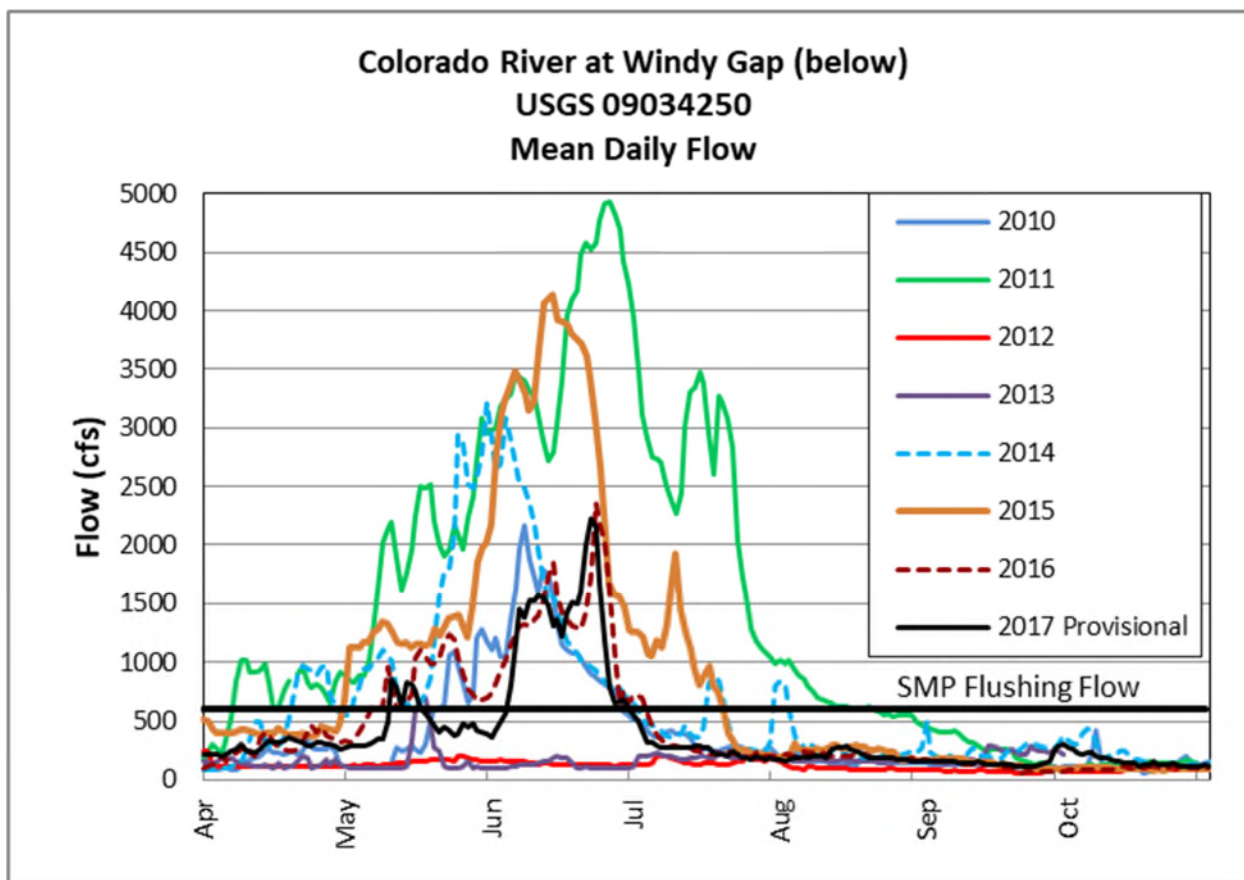
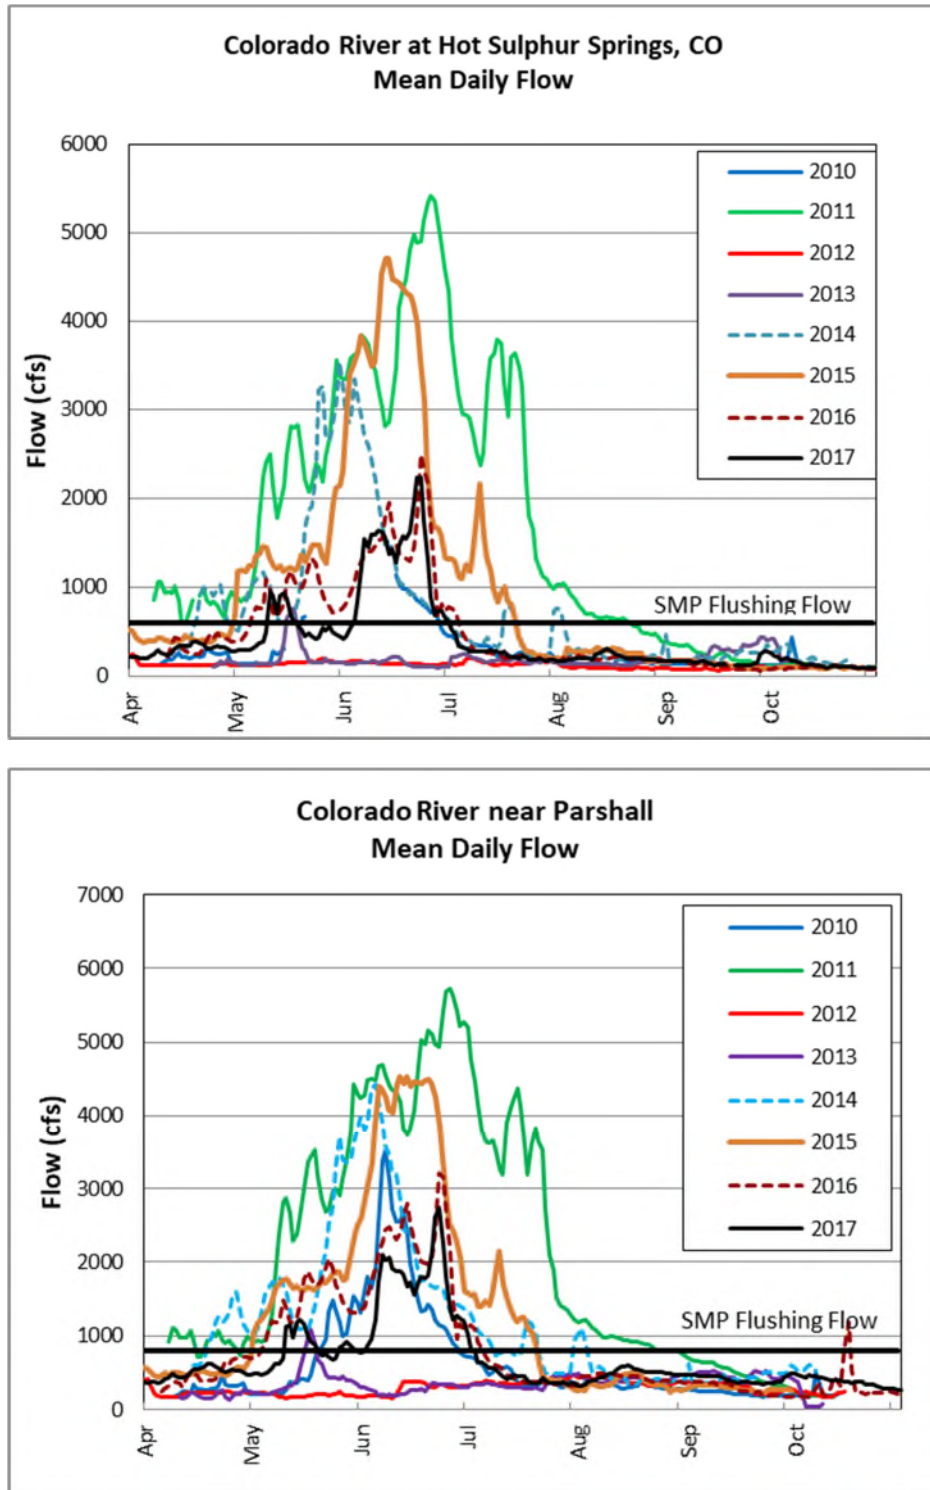
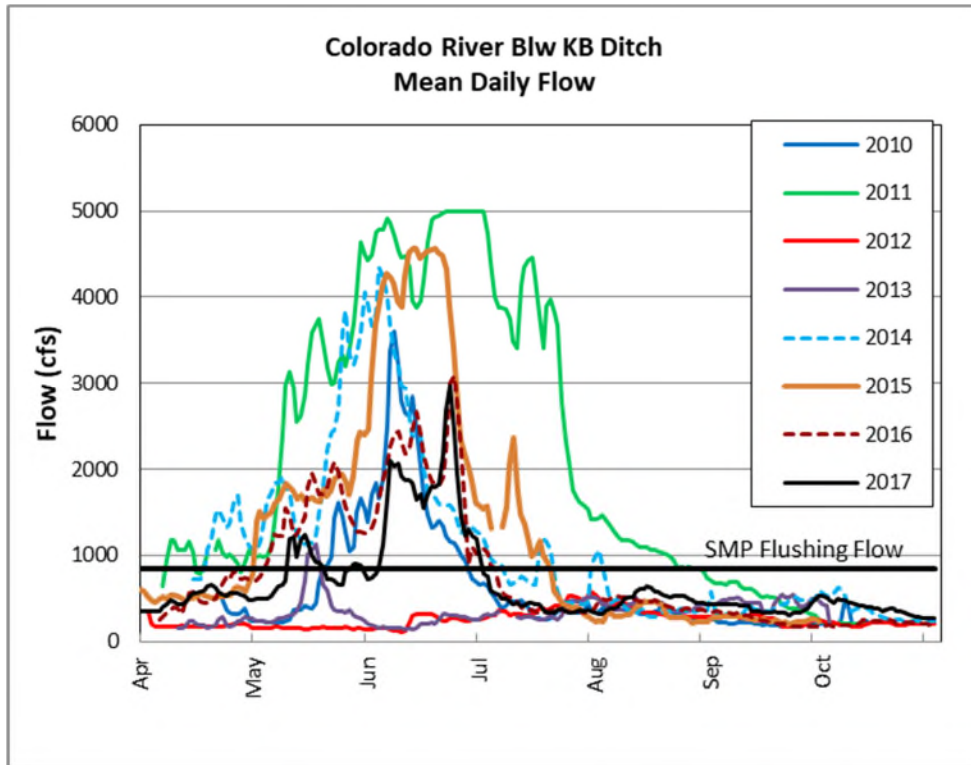
Figure 7 Hydrographs for April through October 2010-2017 for five Colorado River stream gage stations in Grand County, Colorado. Hydrographs depict time period of interest or as limited by available data.

Figure 7 continued. Hydrographs for April through October 2010-2017 for five Colorado River stream gage stations in Grand County, Colorado. Hydrographs depict time period of interest or as limited by available data.

2017 spring runoff on the Colorado River through Grand County was somewhat lower than those observed in 2014 to 2016, but 3.7 to 9.1 times higher than those experienced in the dry years of 2012 and 2013 (**Figure 7** and **Table 13**). Streamflows peaked in mid- to late June and ranged from 2,238 cfs below Windy Gap to 4,280 cfs at Kremmling. These peaks had an estimated return interval of about 4 years based upon the 1986 to 2016 period of record (**Appendix A**). Flows generally remained high through June and early July declining toward base flow levels by mid-July. Late summer releases from William’s Fork and Green Mountain Reservoirs kept baseflows somewhat elevated through Reaches CR5, 6, and 7, delaying some field sampling until October. The recommended flushing flows (Table 13) on the Colorado River through Grand County were exceeded in both magnitude and duration during 2017.

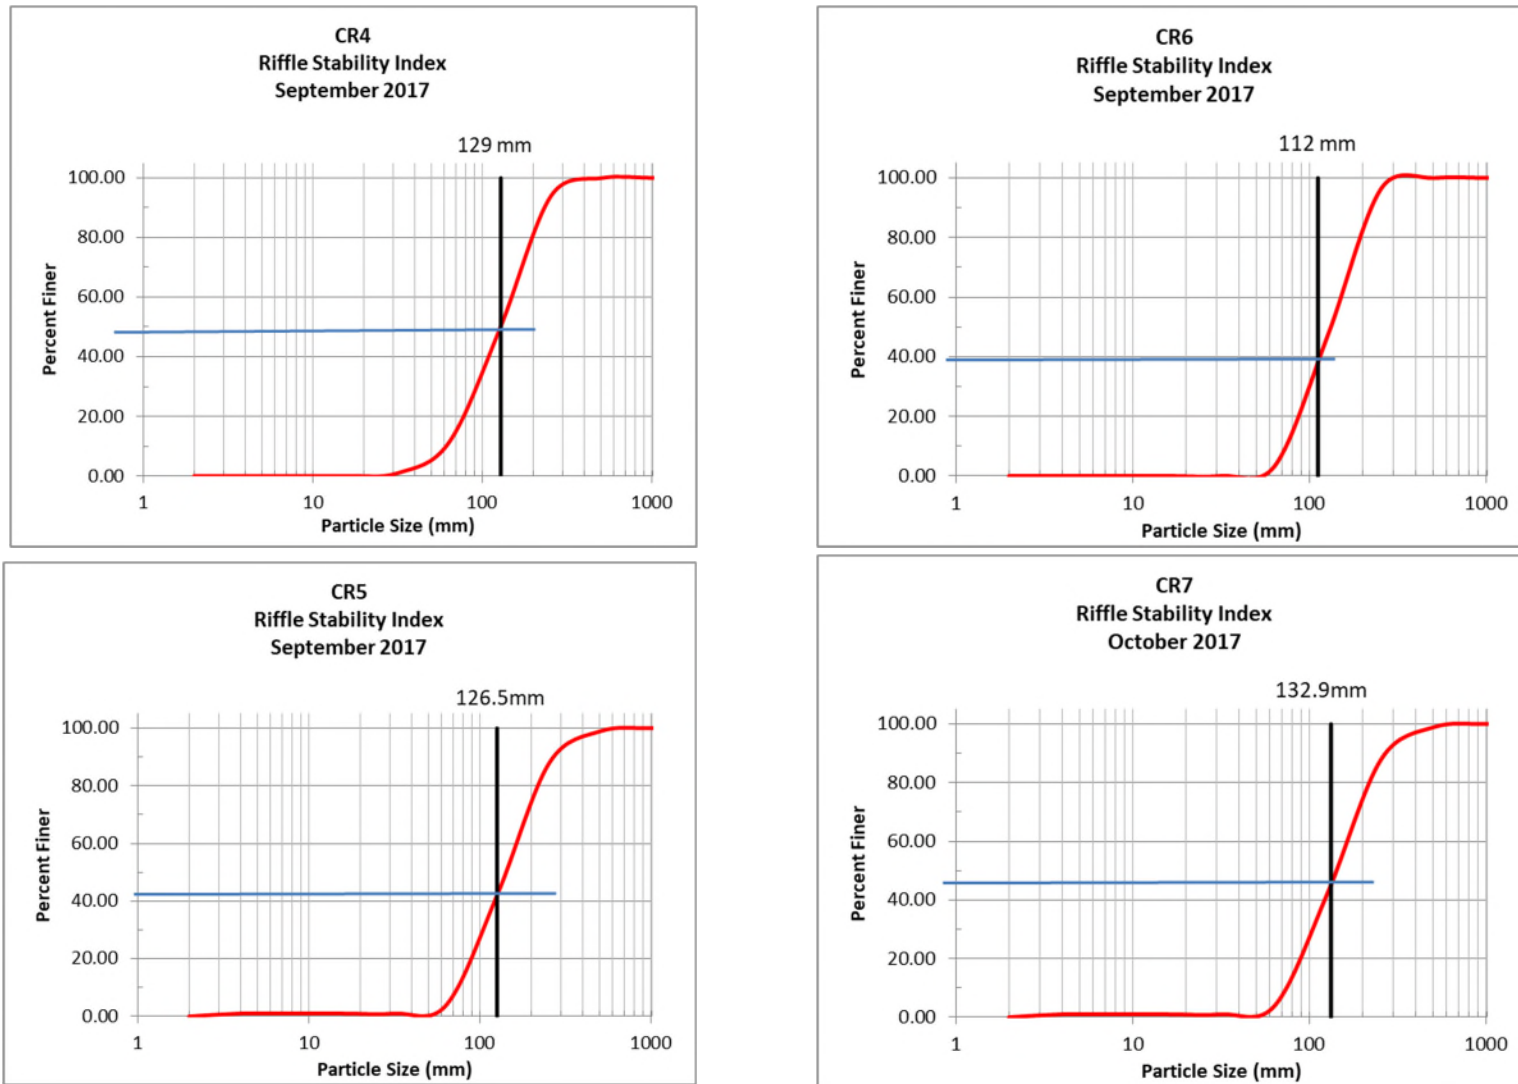
Figure 9 Riffle Stability Index (RSI) results for the four Colorado River spawning bar sites, 2017 (red line represents sample gradation, blue line represents percent of mobilized riffle substrate, and black line represents mean of the largest bar size material mobilized).

These findings are comparable to those of 2014 to 2016 (**Table 16**), and are supportive of observation last year (Tetra Tech and HabiTech 2017) that peak flows in the range of the 3-year return interval event are sufficient to initiate cobble mobilization and riffle maintenance. The 3-year events for the three Colorado River gage stations analyzed are estimated to be 1,702 cfs at Windy Gap, 2,239 cfs near Parshall, and 3,890 cfs at Kremmling (Appendix A). All four of the Colorado River RSI riffles were exceptionally clean in 2017, with less than 3% embeddedness at each. Likewise, sand and finer (<2 mm) substrate was observed at less than 1% of pebble count locations in the RSI riffles, well below the CWQCC guideline threshold of 27.5% to prevent impacts to macroinvertebrate communities in Sediment Region 1.

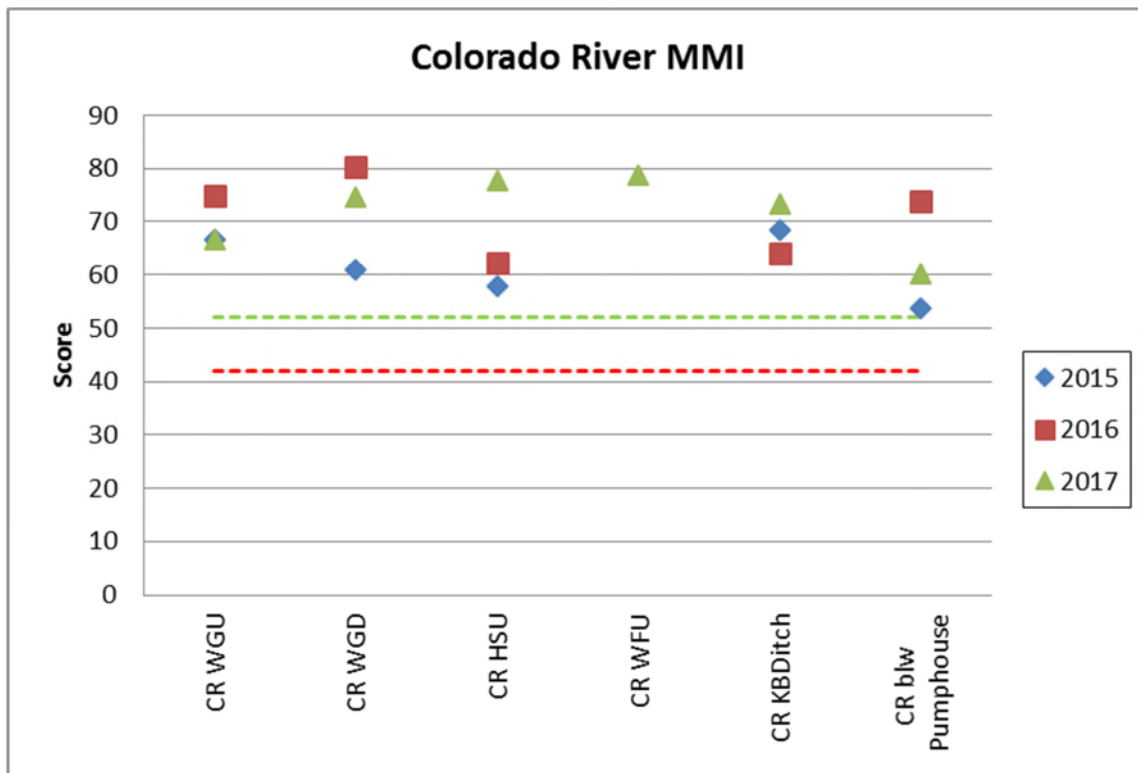
Figure 10 Trend of Colorado MMI scores from upstream to downstream, 2015-2017. Red and Green dashed lines depict boundaries of MMI "gray zone."

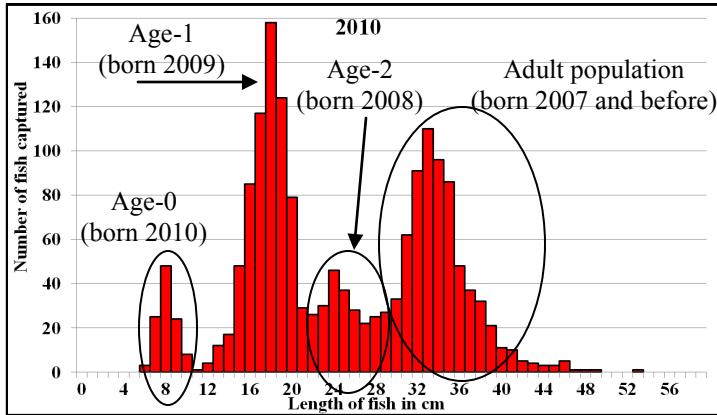
Brown trout population size structure

These figures (and the following page) display the size distributions for all brown trout captured in the Parshall-Sunset reach in September from 2010-2017. The vertical axis on all graphs is the same, enabling comparisons among years. The vertical bars represent the number of fish that were captured in each size class by centimeter (15 cm = 6"). Viewing the data in this way reveals a wealth of useful information including rough estimates of annual growth and survival rates. Fish less than 15 cm are not effectively captured during these surveys, so it is difficult to assess the abundance of the age-0 year class (fish that were born the year of the survey) from this data. However, the age-1 year class (born the year prior to the sample), in the 12-20 cm range, is represented more accurately.
