2018 Aquatic Resource Monitoring Report

Learning By Doing 2018 Notable Events

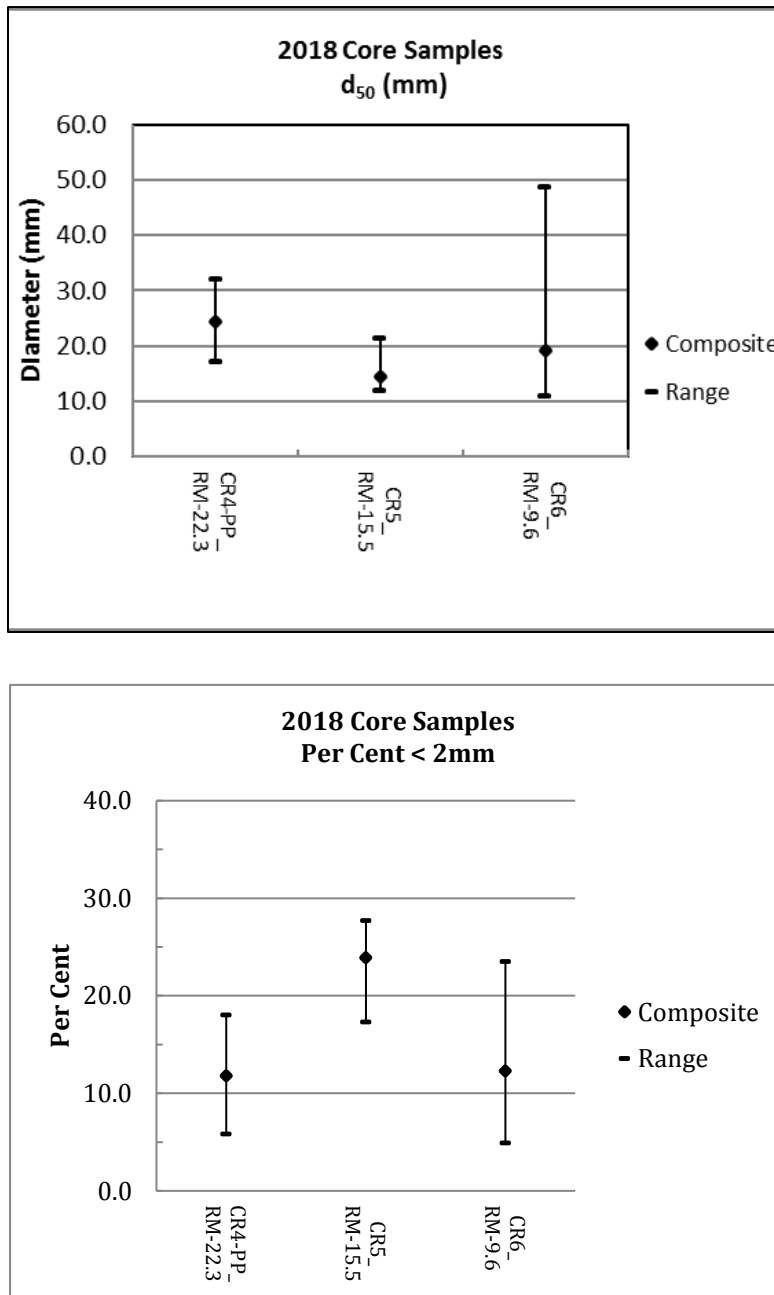
Figure 8. Composite and range of median particle sizes (d₅₀, mm) and percentages of sediment <2mm for the six core samples collected at three Colorado River spawning bar study sites, 2018.
