# LEARNING BY DOING

2019 Aquatic Resource Monitoring Report

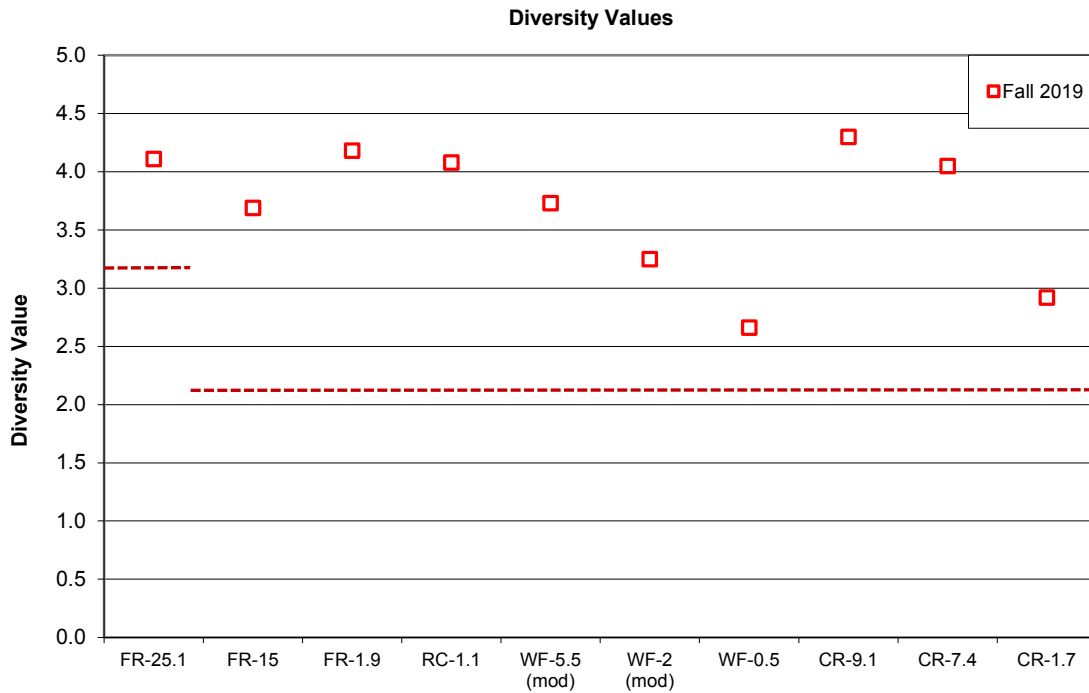
**Figure 3. Diversity values from study sites in the Learning By Doing study area during fall 2019. The red line indicates the impairment threshold for Biotypes 2 and 1.**

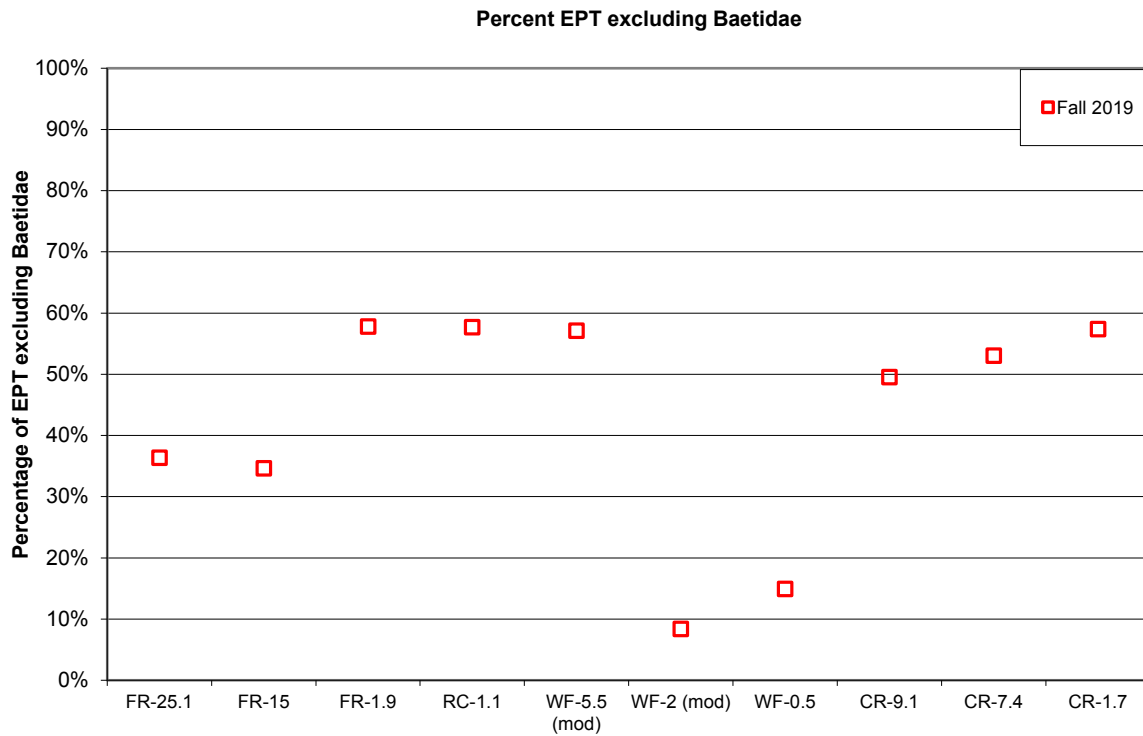
**Figure 6. Percent EPT (excluding Baetidae) values from study sites in the Learning By Doing study area during fall 2019.**

On the Colorado River, the additional individual metrics continued to detect healthy benthic community parameters while demonstrating some of the highest macroinvertebrate densities in the study area (Table 4). The Taxa Richness, EPT, and % EPT (excluding Baetidae) metrics all performed well relative to other sites in the study area, indicating that sampling locations on the Colorado River were able to support taxa-rich communities with high proportions of sensitive individuals. The most optimal values (in the entire study area) for the Taxa Richness and EPT metric (58 and 29, respectively) were found at site CR-7.4. The abundance (Density) of macroinvertebrates was also higher (12,549 individuals/m<sup>2</sup>) at this site than any other sampling location (Table 4). Some of the best evidence of shifts in macroinvertebrate community structure among sites on the Colorado River was provided by the Percent Hydropsychidae metric, which declined in a downstream direction between sites CR-9.1 and CR-1.7 (Table 4). In general, most of the subtle changes in community structure in the Colorado River could probably be attributed to changes in habitat. Although the stonefly *Pteronarcys californica* was not collected during the fall of 2019, all three study sites on the Colorado River were populated with a variety of other sensitive and specialized taxa.

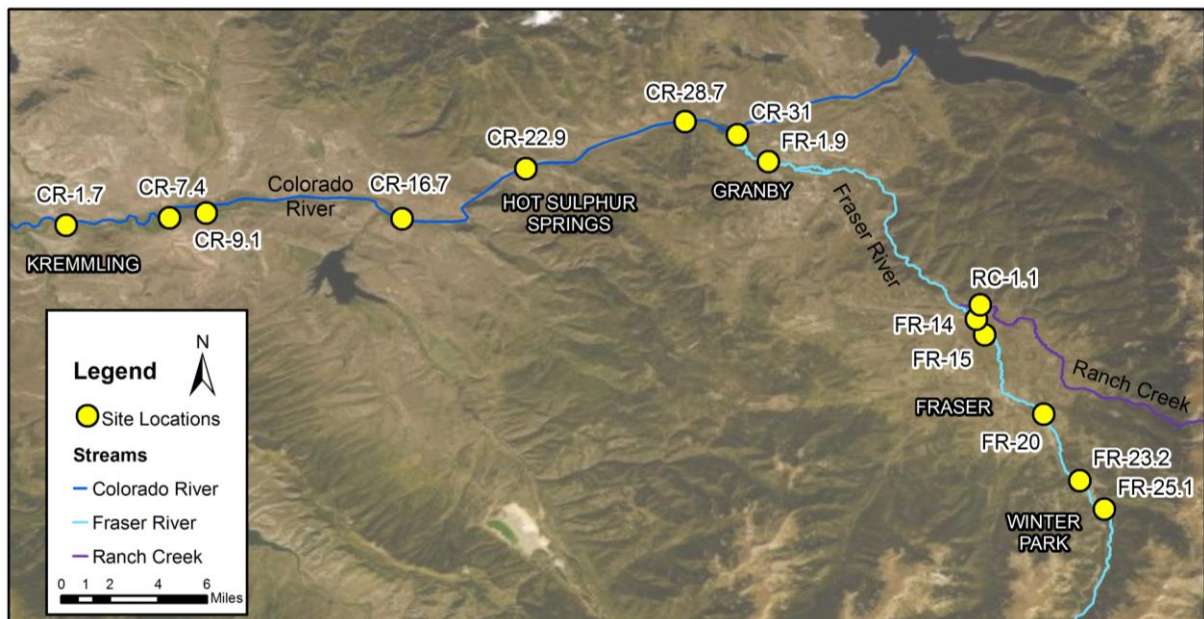
**Figure 2-1: All sediment and algae assessment site locations on the Colorado River, Fraser River, and Ranch Creek.**

All sites sampled were located within the Grand County LBD’s Cooperative Effort Area (CEA) in Grand County. This area stretches from the town of Winter Park, CO approximately 50 miles downstream to the town of Kremmling, CO (Figure 2-1; Table 2-1). The seven sites on the Colorado River extend from the town of Granby, CO to the town of Kremmling, CO. The six sites on the Fraser River extend from the town of Winter Park, CO to the town of Granby, CO. The one site established on Ranch Creek is located in the town of Tabernash, CO, approximately 0.75 miles (mi) upstream from the confluence with the Fraser River (Figure 2-1).

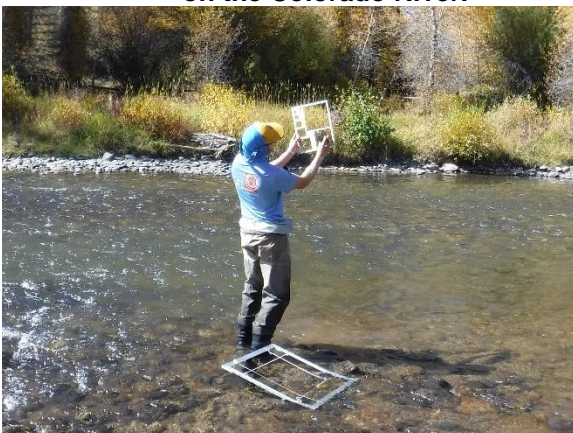
**Photo 3-1: Substrate being measured with a gravelometer at Site CR-16.7 on the Colorado River.**

At each site location, pebble counts were performed utilizing the method outlined by Colorado WQCD Policy 98-1 which describes the Modified Wolman Pebble Count Method (CDPHE 2014). A total of ten transects were established at each site, evenly spacing each transect along a length of stream approximately twenty times the average bankfull width. At each of these ten transects, a 60 by 60-centimeter (cm) sampling frame was used to designate 4 substrate particles for measurement at ten evenly spaced points across the transect (Photo 3-1). This accounted for a total of 40 substrate particle measurements per transect, and a total of 400 measurements per sampling location. The 60 by 60 cm sampling frame consisted of 4 aluminum bars connected to form a square, with an inside width of 60 cm, and 4 elastic bands placed forming four cross sections with a width of 50 cm. The intermediate axis of each particle designated by the elastic band cross sections on the sampling frame was measured using a gravelometer or ruler (if the particle was too large to fit through the apertures in the gravelometer). Ocular estimates were used for substrate particles that could not be removed from the bed and measured with a ruler (i.e., due to size).

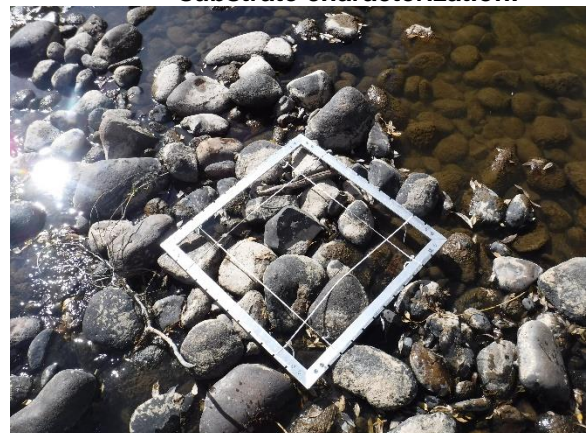
**Photo 3-2: Sampling frame with four cross sections for randomized substrate characterization.**

A subset of the particles measured at each of the transects at each site location were used to determine percent embeddedness, or the extent to which larger particles are surrounded by or buried in fine substrate. A minimum of four or five large gravel or cobble-sized particles at each transect were measured for percent embeddedness, for a total of 40 to 50 embeddedness measurements per sampling location. Embeddedness percentages were determined by measuring the height that each particle was buried and dividing by the total particle height. This method allowed for a quantitative estimate of the total percent embeddedness at each site.

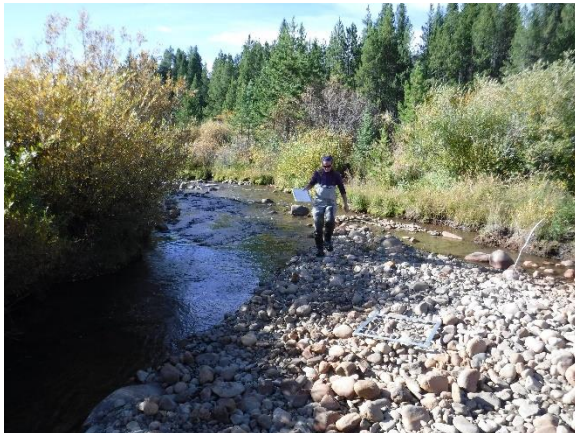
**Photo 3-3: An example of a depositional point bar, from Site FR-23.2 on the Fraser River.**

The Riffle Stability Index (RSI) was determined at each site using the methods outlined by Kappesser (2002). The RSI value indicates the percentage of mobile bed material in the riffle. A point bar, lateral bar, or similar depositional feature at each site location was identified in close proximity to a riffle. A transect was established in a riffle, across its bankfull width, and 200 substrate particles were selected. In smaller streams with insufficient width to allow selection of 200 particles, a second transect was established. The intermediate axis of each particle was measured. On the depositional feature, the intermediate axis of 10 to 30 of the largest recently deposited particles were measured, and the geometric mean of these particles was calculated. The geometric mean was then compared to the cumulative distribution of particle sizes from the 200-riffle pebble count. This determined the percentage of particles in the riffle that were smaller than the representative large mobile particles in the depositional feature at each site. The mobile fraction on the riffle can be estimated by comparing the relative abundance of various particle sizes present on the riffle with the dominant large particles on an adjacent bar (Kappesser 2002).

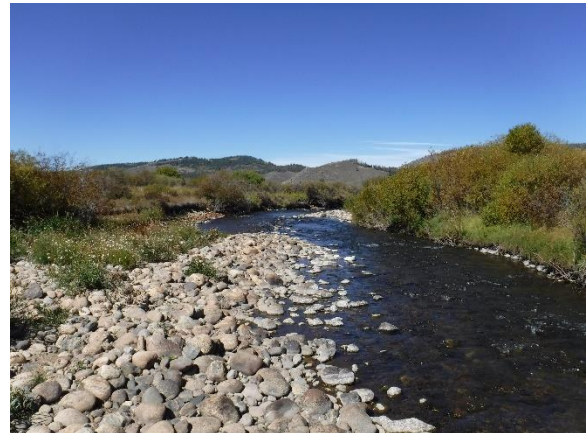
**Photo 3-4: An example of a lateral depositional bar, from Site FR-14 on the Fraser River.**

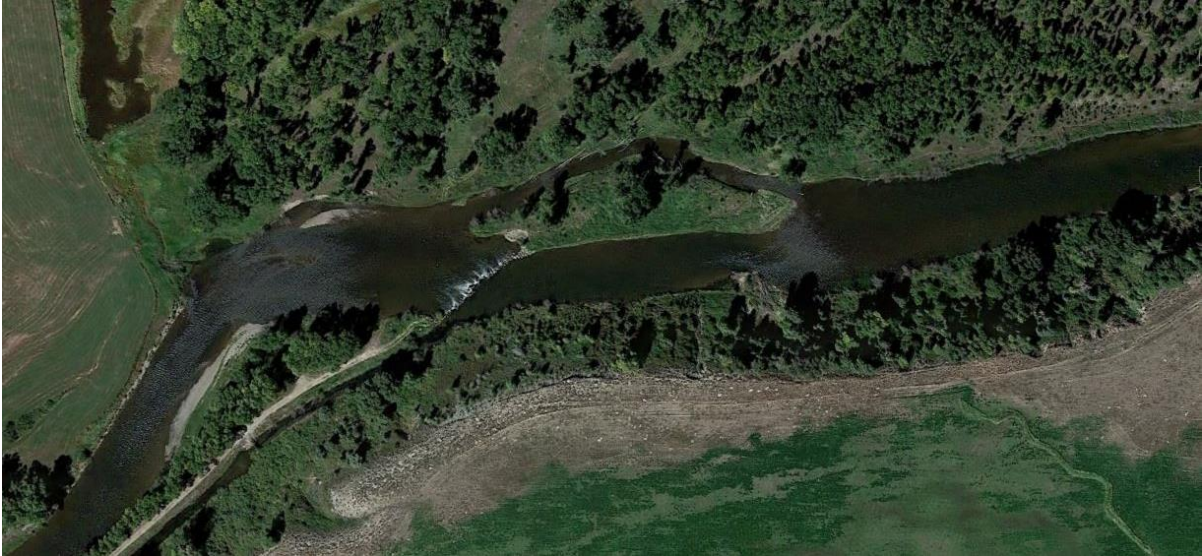
**Photo 5-1: Aerial image of the KB Ditch diversion and inlet (Google Earth, [earth.google.com/web/](http://earth.google.com/web/)). The Colorado River flows towards the left of the photo.**

There are two relatively large tributaries to the Colorado River in the downstream portion of the study reach that likely influence substrate characteristics in the river. The Williams Fork of the Colorado River (Williams Fork) flows into the Colorado River just downstream of Site CR-16.7 in the town of Parshall, CO, and Troublesome Creek flows into the Colorado River between Site CR-9.1 and Site CR-7.4. The Williams Fork downstream of Williams Fork Reservoir is a short section of river about 2.0 miles in length before the confluence. This reservoir disrupts the continuity of sediment transport in the Williams Fork and likely diminishes the amount of substrate provided to the Colorado River. The Williams Fork adds a relatively large amount of volume to the flow in the Colorado River, which assists with transporting sediment downstream. Substrate at Site CR-9.1, the first sampling site downstream of the Williams Fork confluence, had smaller proportions of substrate material smaller than 128 mm than observed at the next upstream site, Site CR-16.7. The additional river flow (and therefore, increased water velocity) from the Williams Fork River, combined with its low sediment input, increases the capacity of the Colorado River to move the existing substrate in the vicinity of Site CR-9.1. As expected, the proportion of sediment less than 128 mm in diameter decreases from 66.4% to 58.6% between sites CR-16.7 and CR-9.1. The KB Ditch Diversion also appears to affect sediment dynamics at Site CR-9.1. The KB Ditch is located approximately 0.4 miles upstream of Site CR-9.1 on the Colorado River and diverts flow from the Colorado River for agricultural use. The diversion runs the width of the river at the ditch inlet, with the exception of a small bypass on river right (looking in a downstream direction). This structure also has the potential to trap sediment. The KB Ditch and Williams Fork confluence with the Colorado River are both upstream of Site CR-9.1; without a monitoring site between these two potentially influencing factors. An additional site located between Williams Fork and KB Ditch might determine their relative influences on the sediment characteristics at Site CR-9.1.

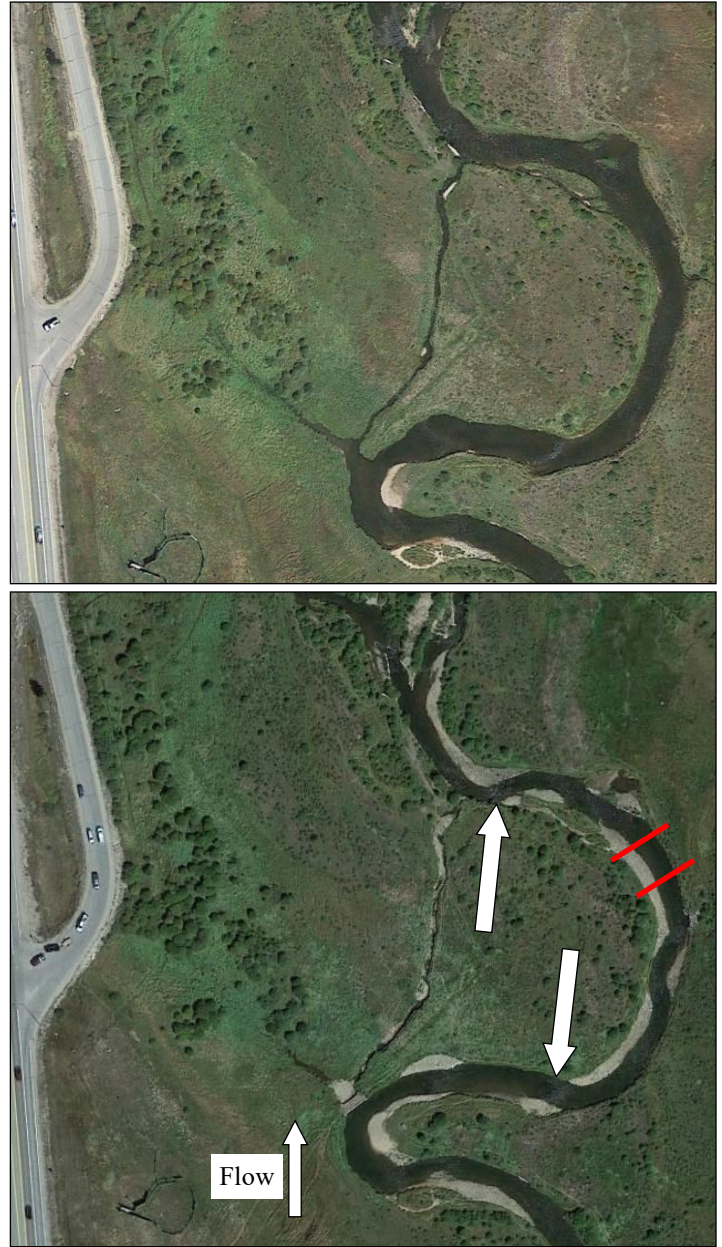
Figure 18. Two views of the Fraser Flats site. The intersection of US Highway 40 and Grand County Road 83 is visible at left in both photos. The upper photo was taken on 9/7/2016 prior to construction of the Fraser Flats Habitat Improvement Project. The flow on that date was approximately 35 CFS. The lower photo was taken on 9/13/19 after construction of the project. Flow was approximately 26 CFS. Channel narrowing with point bar enhancements, thalweg definition and channel-within-a-channel design is clearly visible. The arrows in the lower photo indicate the downstream (top) and upstream (bottom) ends of the fish population survey reach. The red lines indicate the approximate location of the two surveyed cross-sections discussed on page 11.

This reach is on property owned by Grand County Water and Sanitation District 1 immediately outside of Tabernash. In 2017 an in-stream physical habitat improvement project was constructed on the site, a cooperative effort by the Learning By Doing stakeholder group and was opened to public access for the first time in 2018. Prior to the habitat project, this reach had relatively poor trout habitat characterized by a high width-to-depth ratio, poor thalweg definition, sparse and shallow pools, and excessive riffles. All of these deficiencies were addressed in the design of the project. This location is also the site of a large willow planting effort undertaken by LBD stakeholders and local volunteers in an effort to restore the willow riparian community. This effort appears to have been initially successful, and the results will develop over the coming decade as the planted willows mature. The fishery surveys discussed here were obtained on a reach measuring 600 feet in length and 35.9 feet in average wetted width (Figure 18).

Figure 20. Simple cross-section surveys collected at two sites within the Fraser Flats Habitat Improvement Project reach (for locations, see Figure 18 on Page 9). Blue lines indicate water surface elevation at the time of the survey, and black lines indicate ground elevation. Cross-section #1 before (top) and after (bottom) habitat work is at left, and Cross-section #2 is at right.

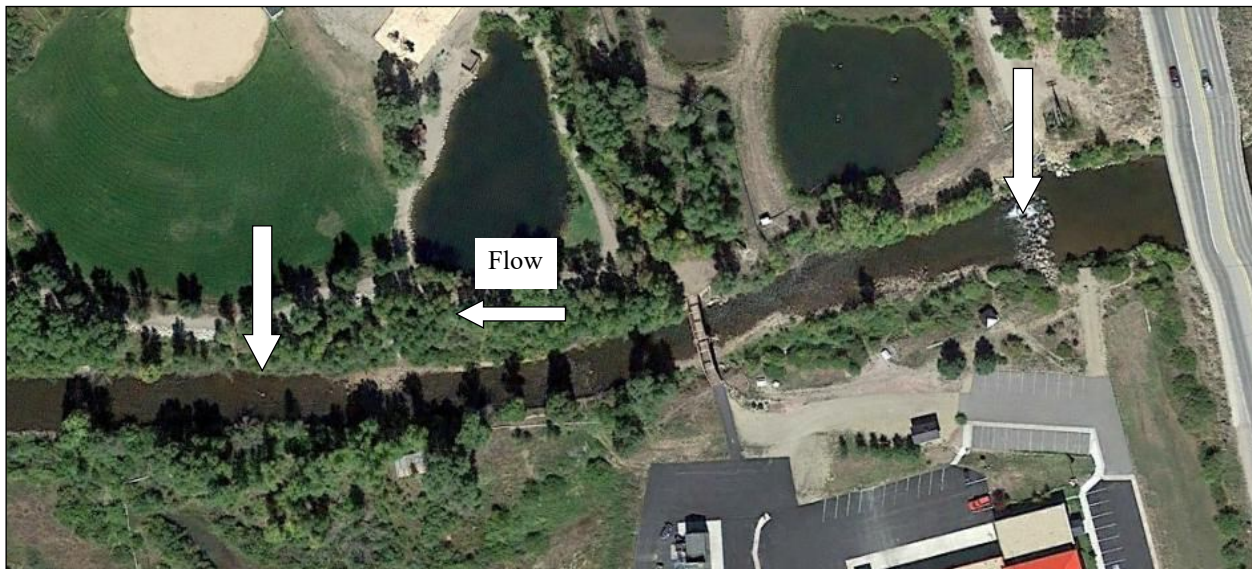
Figure 26. Location of Fraser River Kaibab Park survey station. US Hwy 40 bridge is visible at right.

The Kaibab Park station is located in the town of Granby where the Fraser flows between the park and the fire station, immediately downstream of the Highway 40 crossing (Figure 26, below). The site measures 650 long by 33.4 feet in average width. This is the farthest downstream site on the Fraser that we survey regularly. Only Brown Trout population estimates are presented (Figures 24 & 25, right) because Rainbow Trout have not constituted a significant portion of the fish population, despite the fact that Rainbows have been stocked here on the same occasions that were successful farther upstream.

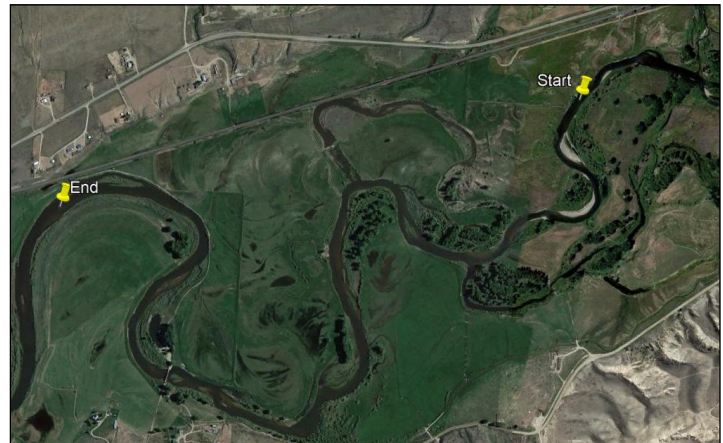
Figure 1. Location of ILVK reach on the Colorado River east of Kremmling. The Troublesome Creek confluence is visible at upper right.

Since 2016, Colorado Parks and Wildlife (CPW) aquatics crews, local landowners, and U.S. Bureau of Land Management (BLM) personnel have surveyed the fish population on a 2.8-mile reach of the Colorado River east of Kremmling (Figure 1). Surveys have occurred annually in the spring. The purpose of these surveys was to establish baseline estimates of the resident fish populations prior to large-scale habitat improvement and stabilization work being constructed by the Irrigators of the Lands in the Vicinity of Kremmling (ILVK); and then to monitor any changes in fish populations following construction of ILVK projects. The construction work is being funded in part by the Colorado Water Conservation Board and Colorado Basin Roundtable. ILVK is a partner in the Colorado River Headwaters Project, which is a Regional Conservation Partnership Program administered by the Natural Resources Conservation Service. CPW is an active participant in the program in multiple capacities, one of which is monitoring fish populations. Land ownership along this reach consists of a succession of private ranches as well as a small amount of BLM property.
