Comprehensive Watershed Assessment: Data Analysis Results

Part 2

Watershed Assessment Goal: Assess hydrological regime characteristics, water rights, water quality, geomorphic, riparian, and biological data relevant to focus streams in the CEA for the purpose of understanding the condition of streams and aquatic habitat within the CEA and the factors that affect their preservation and, where possible, their improvement.

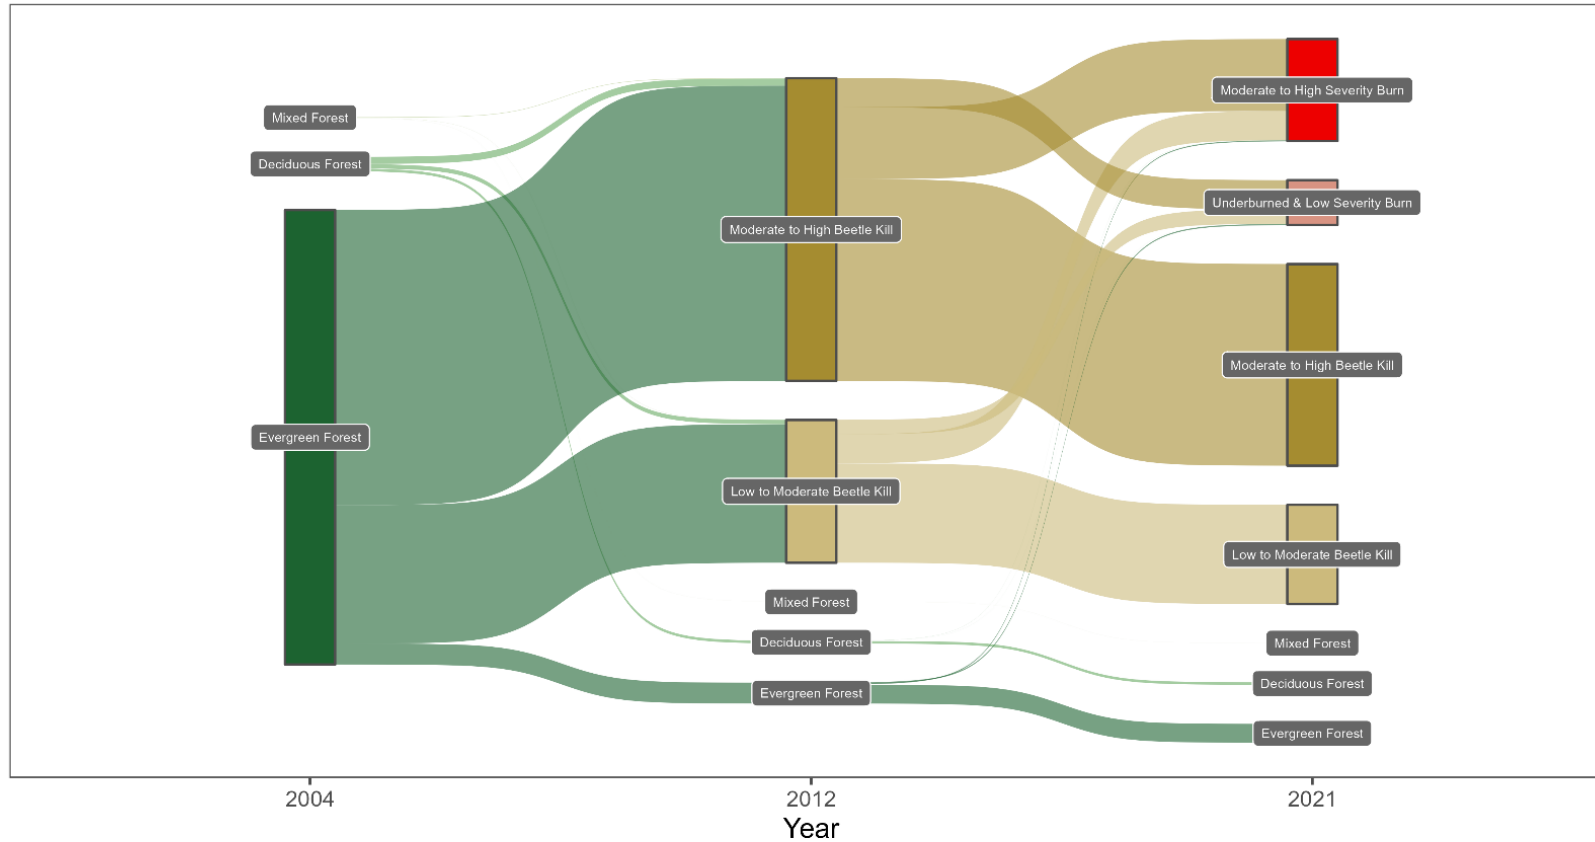
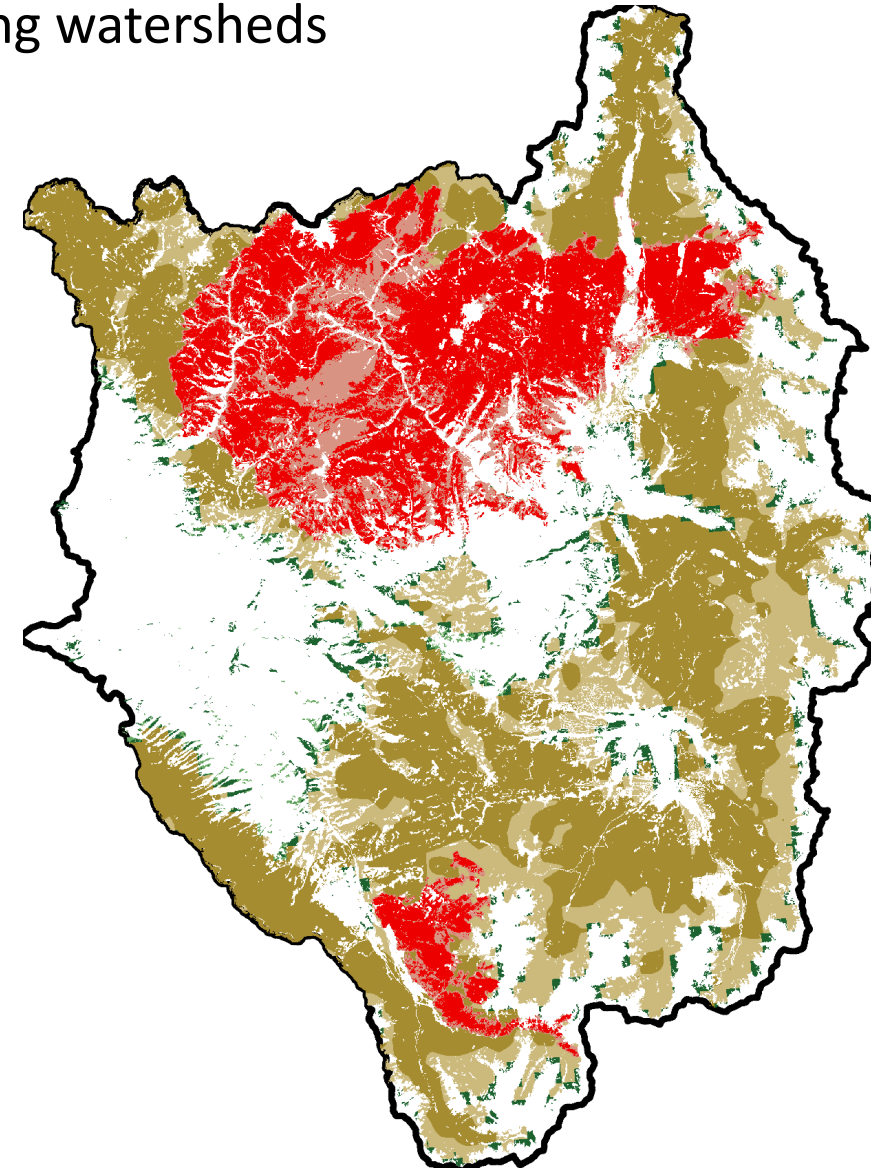
Drivers: Forest Disturbance

- Evergreen forests constitute ~55% of landcover in CEA-contributing watersheds
- 95% of forest impacted by **pine beetle** between 2003-2012.
- 31.4% of forested area **burned** between 2018-2020

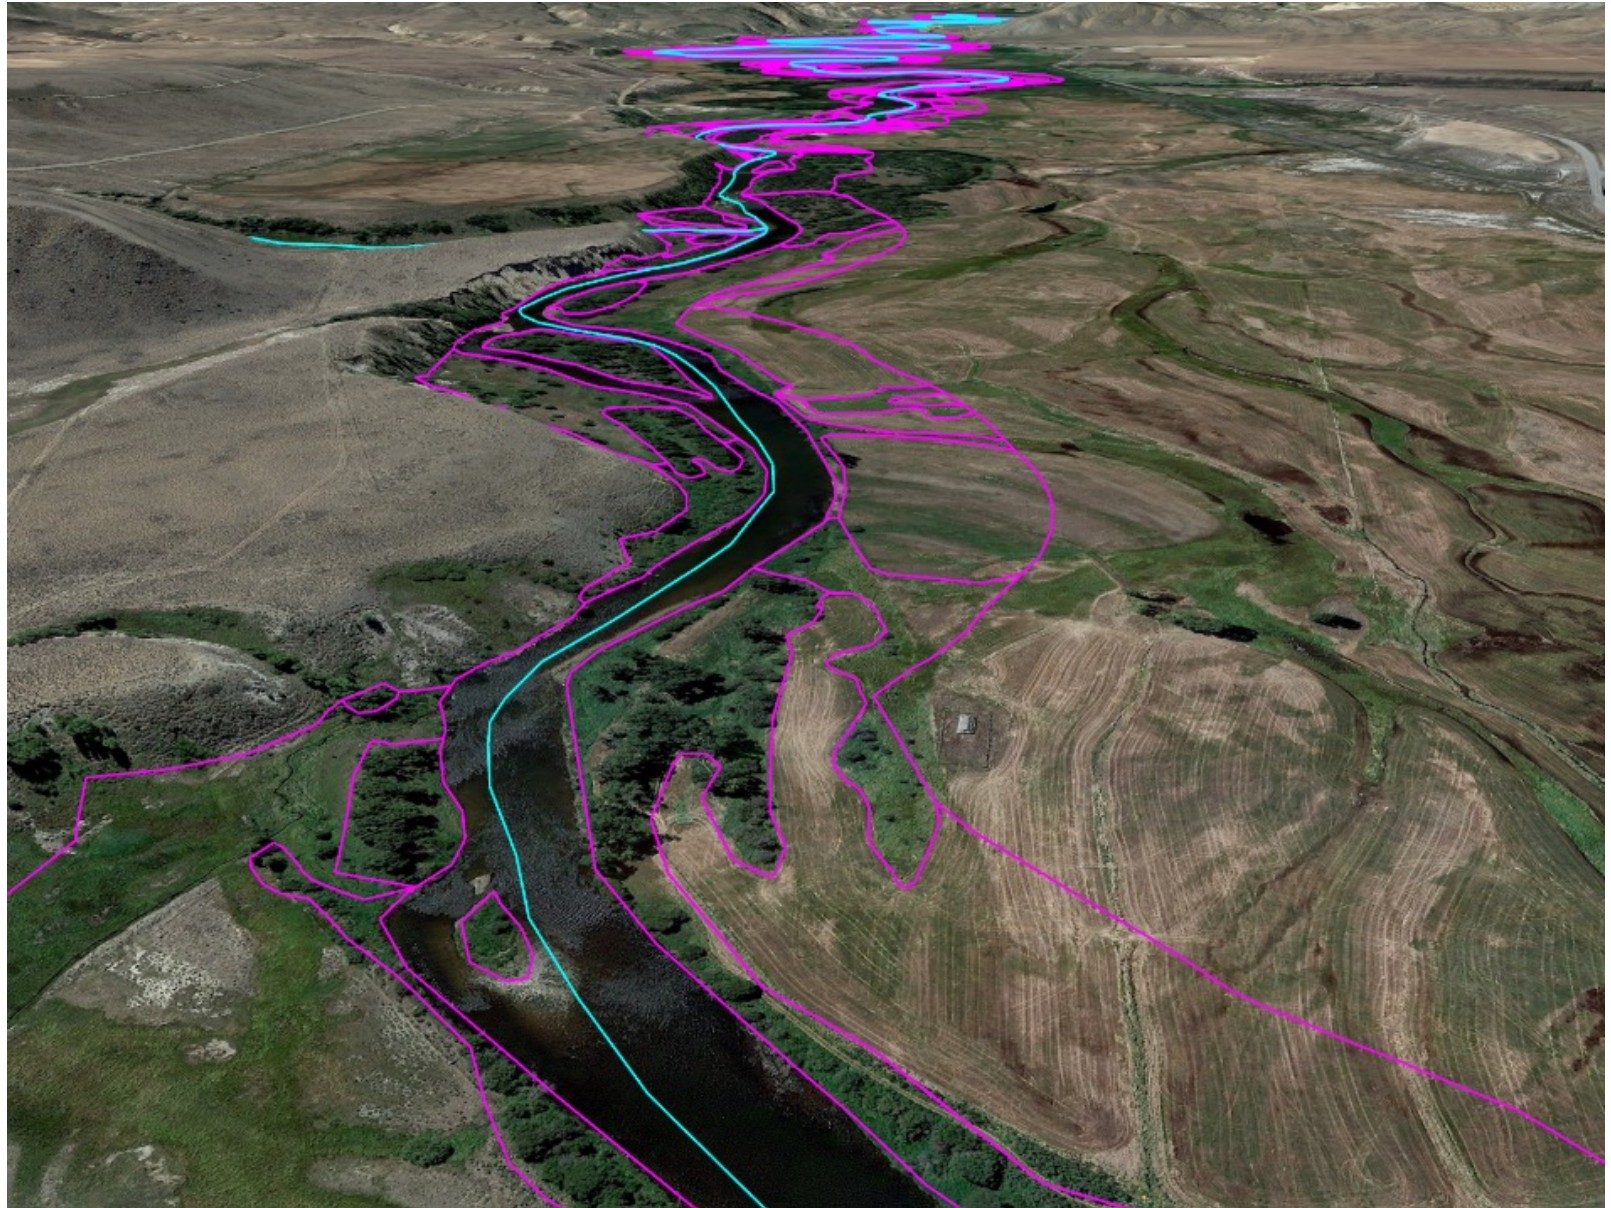
Comprehensive Riparian Condition Mapping Methodology

1. Delineate area of interest

- 100 m for both banks or the natural floodplain, whichever is narrower.

2. Hand digitize land cover classifications

- Relied on 2019 and 2021 NAIP imagery

3. Assign conditional assessment values (i.e., grades)

- Grades reflect departure from natural/pristine conditions

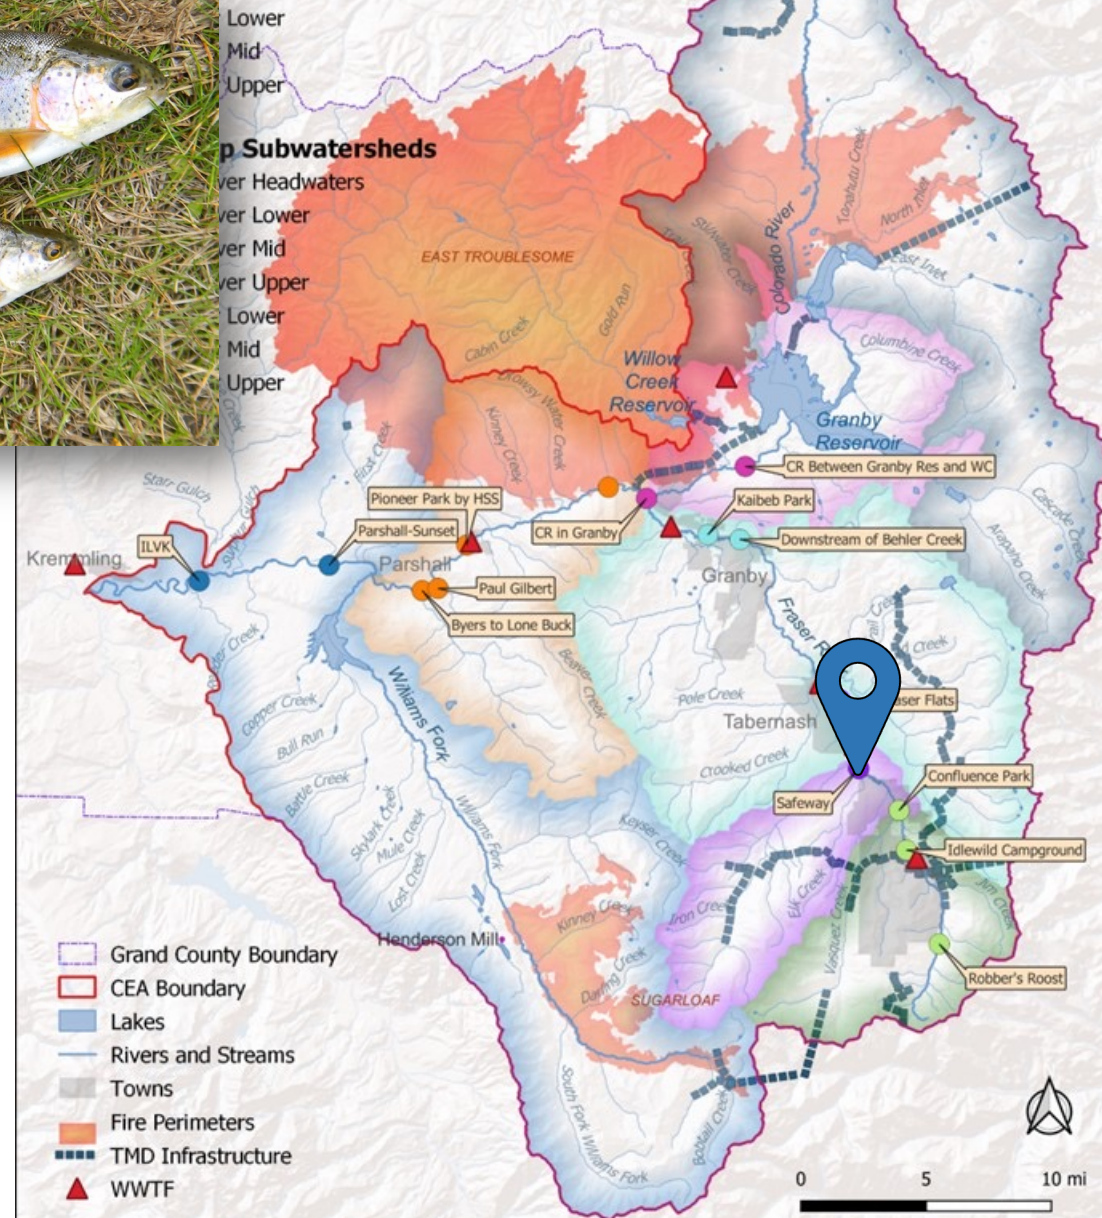
Sport Fish Biomass: Safeway

- Most diverse location on Fraser River
- Browns starting to dominate

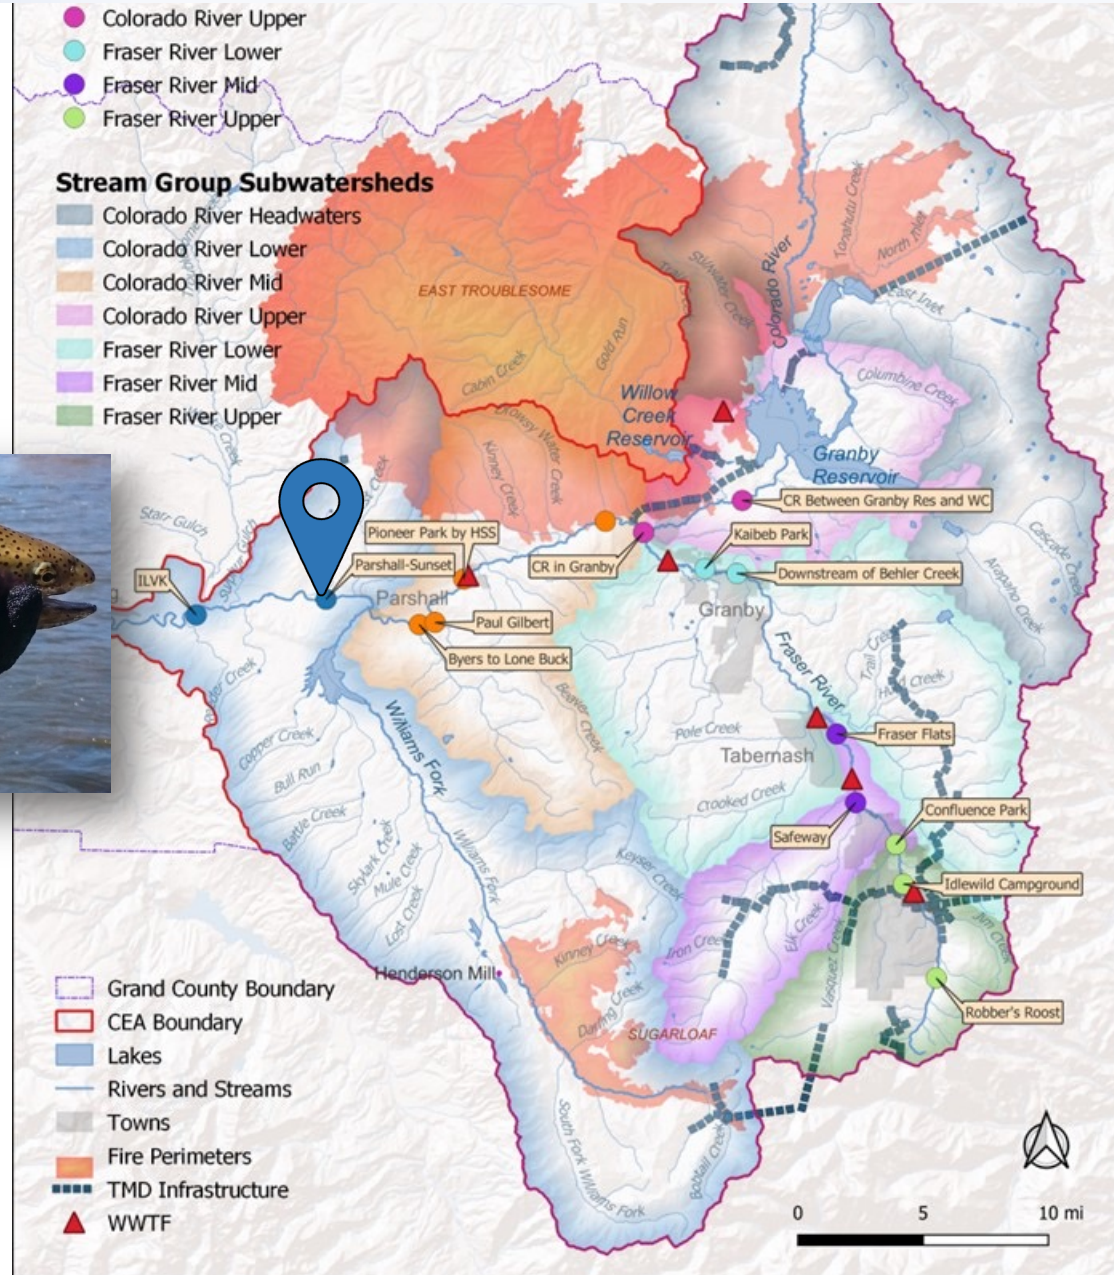
Sport Fish Biomass: Parshall-Sunset

- Rainbows dependent on stocking
- Recent increases in adult brow trout:
 - Emigration from ETF impacted sites ?
