Learning By Doing 2021 Aquatic Resource Monitoring Plan

Aquatic Resource Monitoring Plan Overview

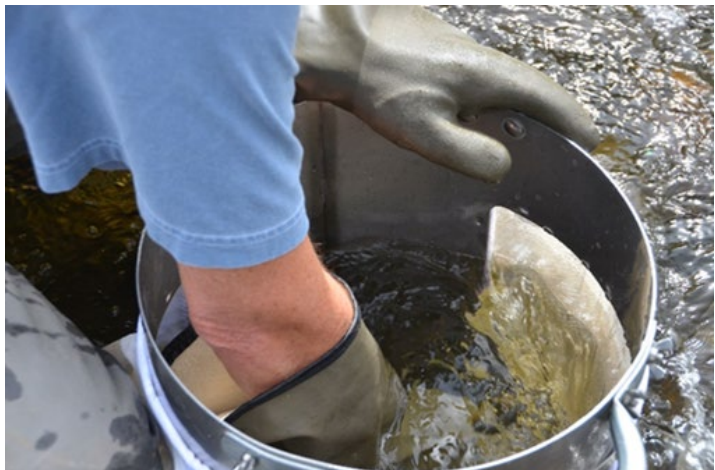
Figure 4 - Sample Collection with a Hess Sampler

March 2019). Samples are collected with a Hess Sampler which is 13 inches in diameter and 16 inches tall with 500 μ m mesh. Three quantifiable Hess samples will be taken from riffle habitat at each of the sites. Each sample is taken from an area of similar size substrate and velocity (if possible) to avoid any bias from these physical parameters when making comparisons among sites (Figure 4).
